RPA ENGINEERING, P.A.

August 27, 2014

**Re: Building Structural Evaluation – 119 W. Water St, Edenton, NC
RPA Engineering Project No. 2014242**

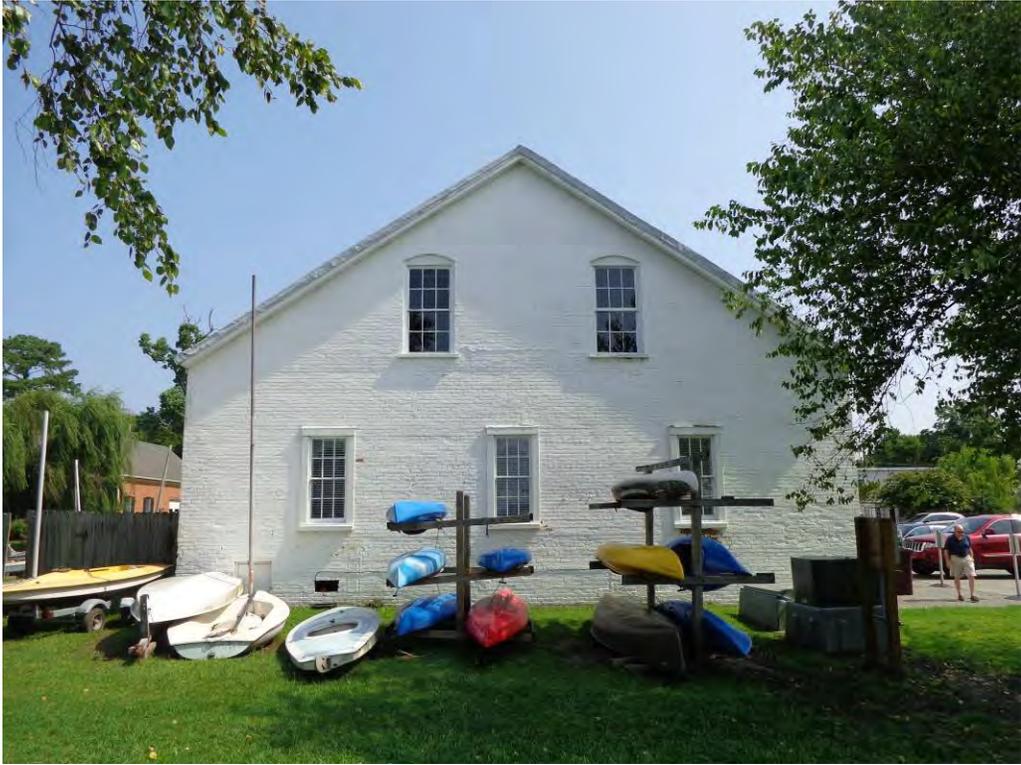
Photograph 1 – Front View

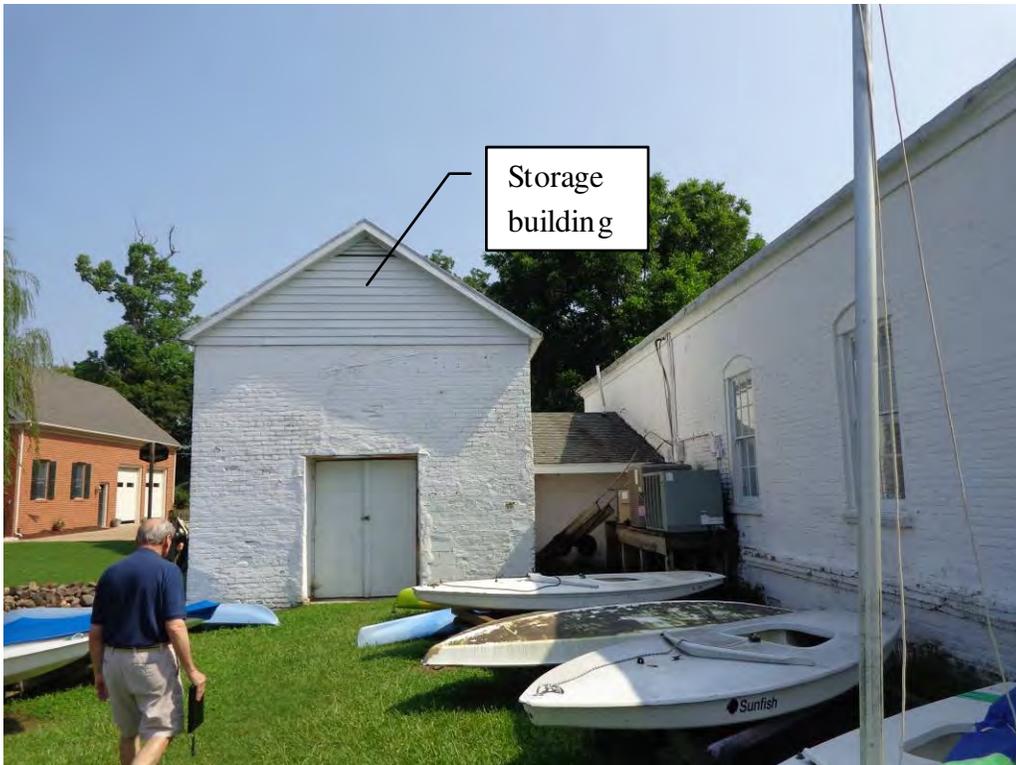
Photograph 2 – Partial Left Side View

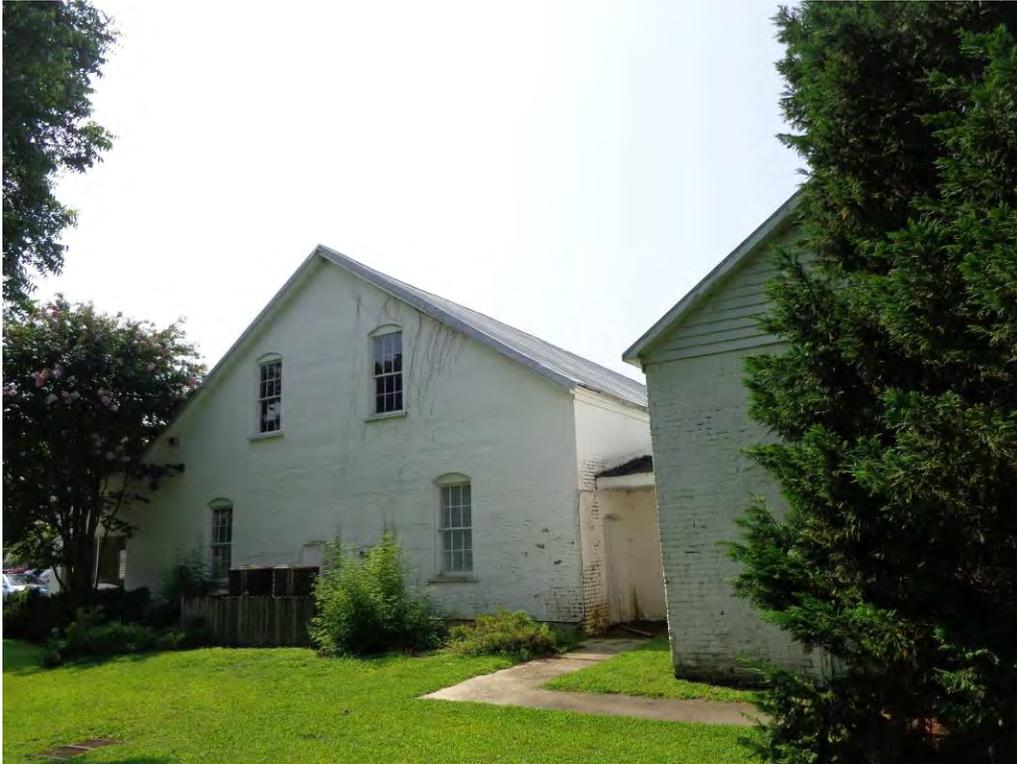
Photograph 3 – Rear View

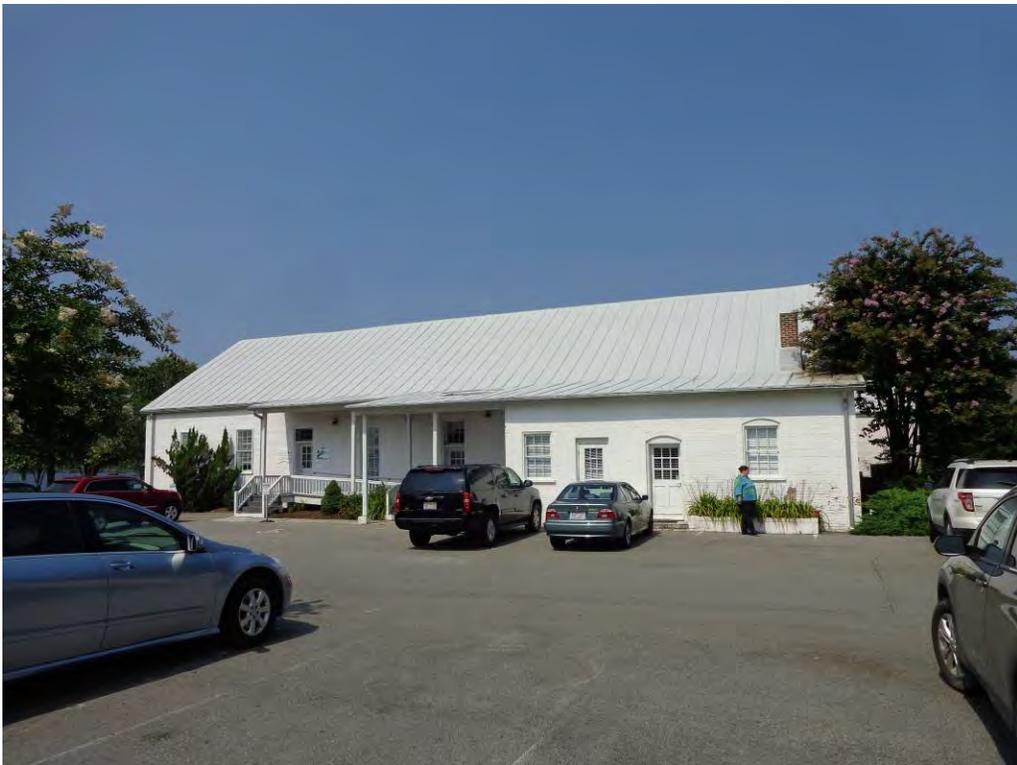
Photograph 4 – Left Side View

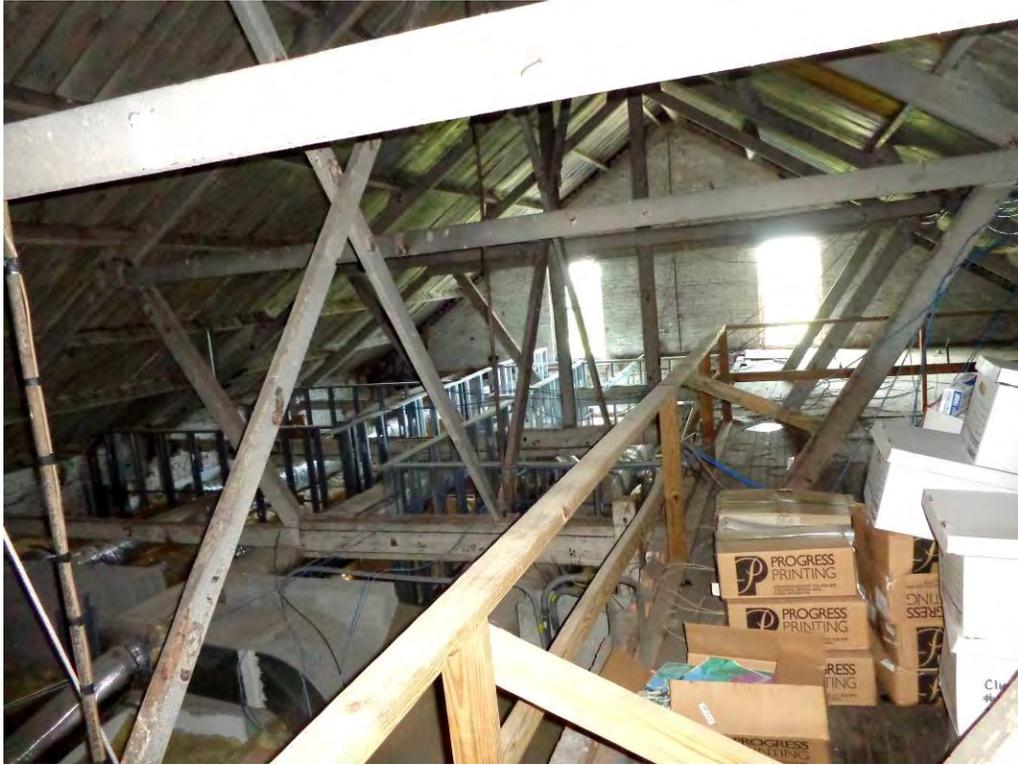
Roof construction consists of timber trusses at about 10' on center which span about 57' between the exterior longitudinal walls. The trusses are built with a combination of timber framing and steel rods. Rough-cut 2x6 rafters span between the trusses and are spaced about 3' to 4'-6" on center. The rafters support 1x4 to 1x12 sheathing boards and metal roofing. The interior stud walls were added after original construction and are not load-bearing.

Photograph 5 – Roof Trusses

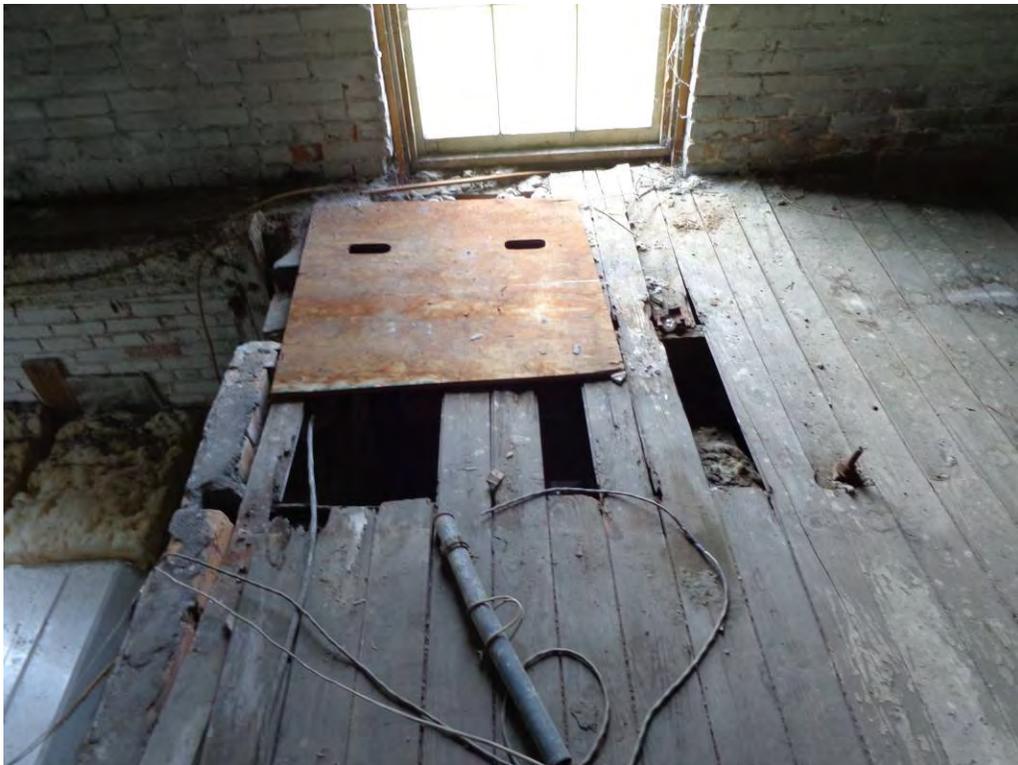
1. The roof framing appeared to be in good condition except for one area at the front wall, near one of the windows, where some of the attic flooring is rotten and a small section of the timber truss bottom chord is partially rotten (see photographs 6 and 7). The flooring can be easily replaced and the truss damage can be repaired by reinforcing the existing bottom chord. The damage appears to be the result of window and/or roof leakage.

Photograph 6 – Damaged Attic Flooring Near Front Wall

The most significant damage identified is the partially rotten truss bottom chord described in item 1. This damage can be repaired by reinforcing the bottom chord member. We can provide additional assistance with this if needed. Otherwise, the building appears to be in good overall structural condition.

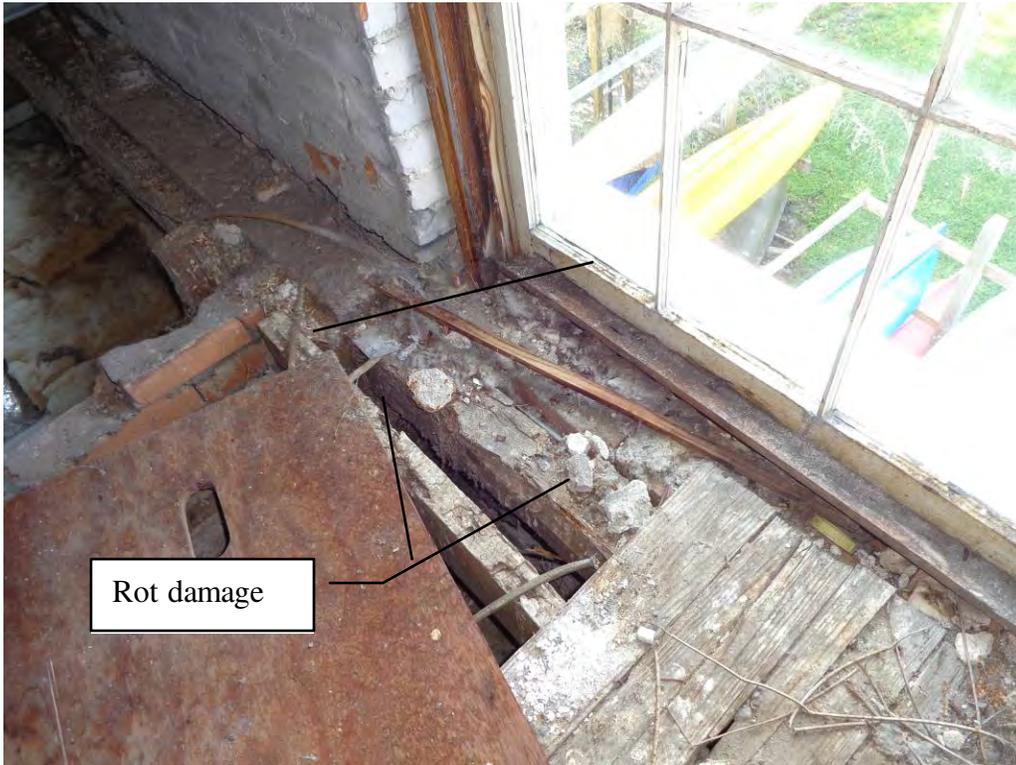
Photograph 7 – Damaged Truss Bottom Chord at Front Wall

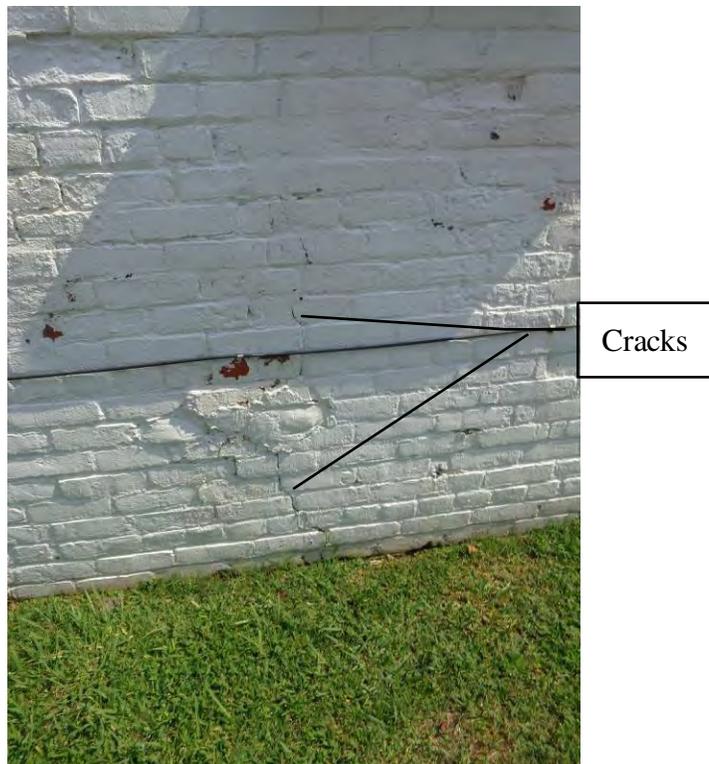
2. There is a hairline crack near the center of the front wall (see photograph 8). This appears to be a settlement crack and is not a significant structural concern. The crack should be repaired by removing loose/cracked mortar and re-pointing with new mortar. There are some areas where other cracks have been repaired but have not re-opened.

Photograph 8 – Cracks at Front Wall

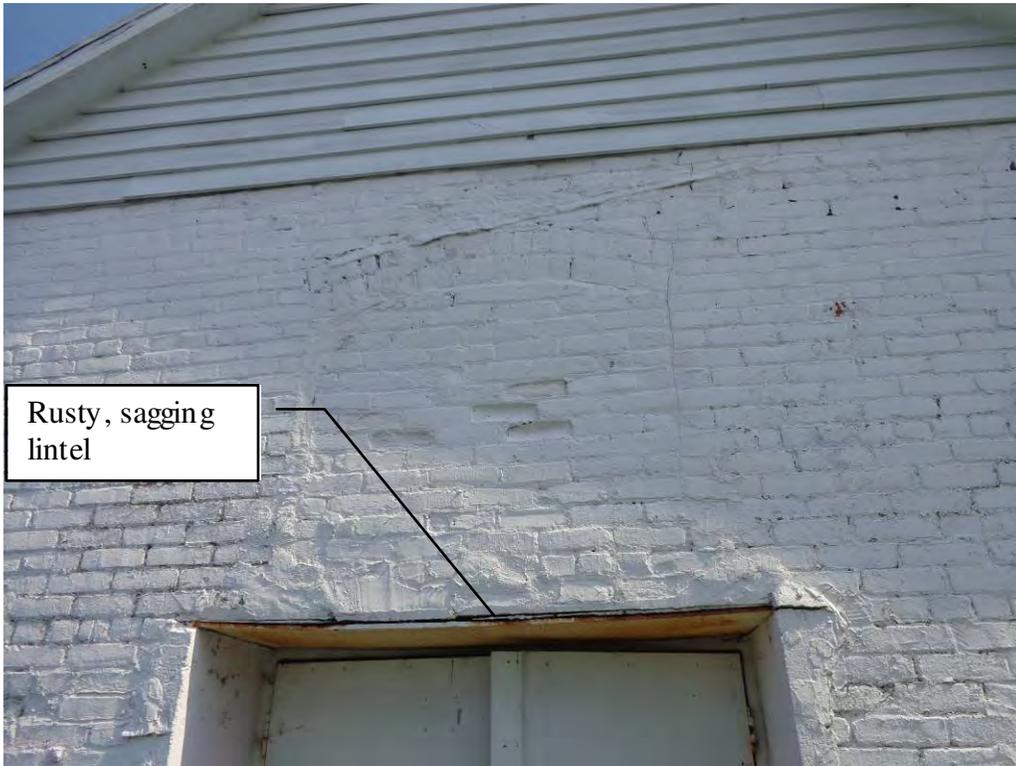
3. The steel lintel plate above the front double doors at the storage building is rusty and sagging (see photograph 9). This lintel is not severely damaged but should be repaired. There is 8" concrete block behind the outer brick that is supported by the plate but the block is not supported by a lintel. Also, there are cracks in the block at the top corners of the door opening (see photograph 10). The cracks appear to be settlement related but could also be related to the lack of a lintel above the door opening. It is recommended that the rusty steel plate be replaced at the outer brick and a new steel lintel installed at the concrete block. Another option is to completely remove the block because it does not appear to be required and is a later addition to the original construction.

Photograph 9 – Damaged Lintel at Storage Building Front Wall

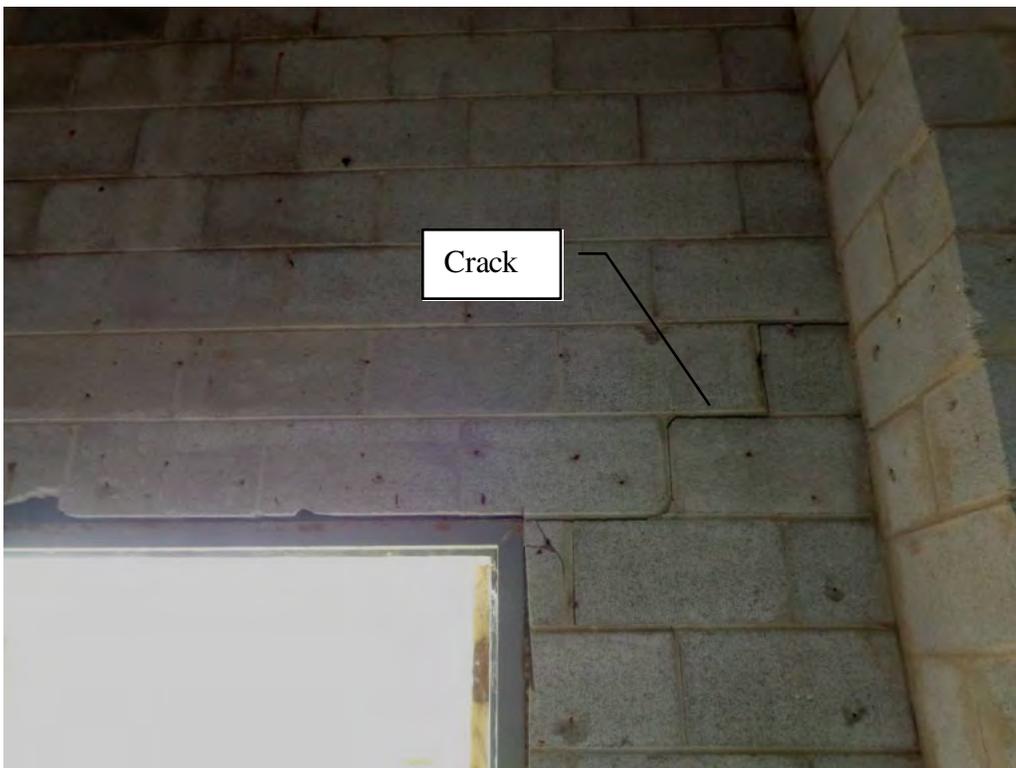
Photograph 10– Crack in Concrete Block at Storage Building Front Wall

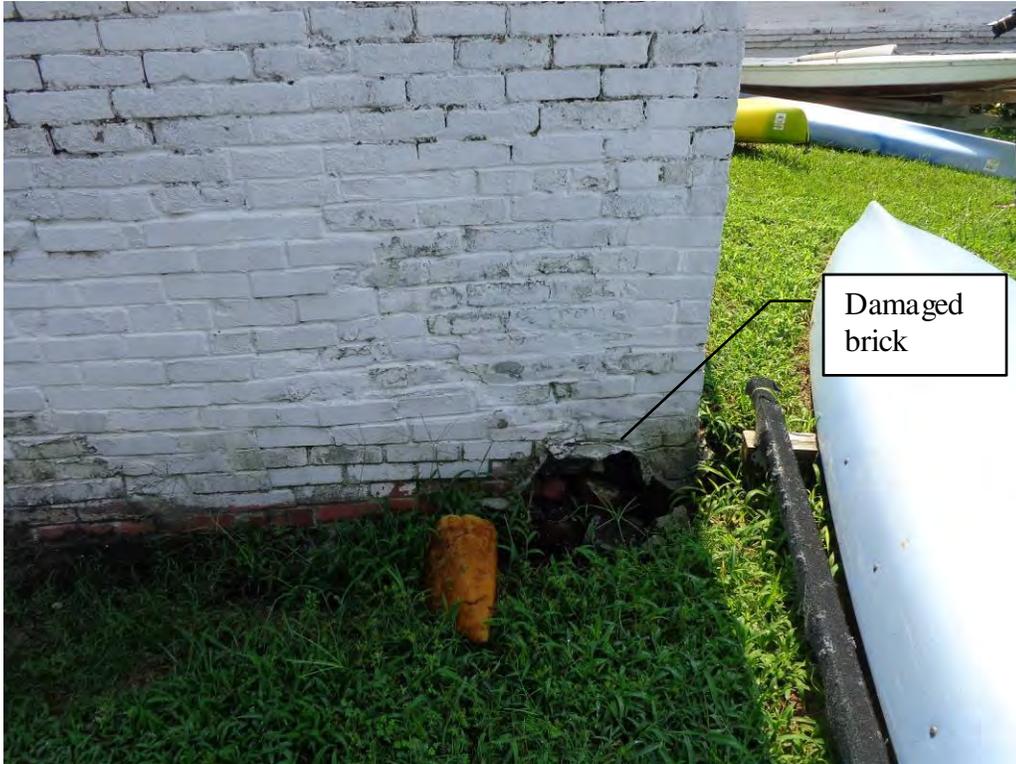
4. There is an area at the front left corner of the storage building where the brick is damaged and the soil adjacent to the front corner and left side wall has eroded. The damaged brick should be repaired and the low ground areas filled and sloped away from the building.

Photograph 11 – Wall Damage and Soil Erosion at Storage Building Front Left Corner

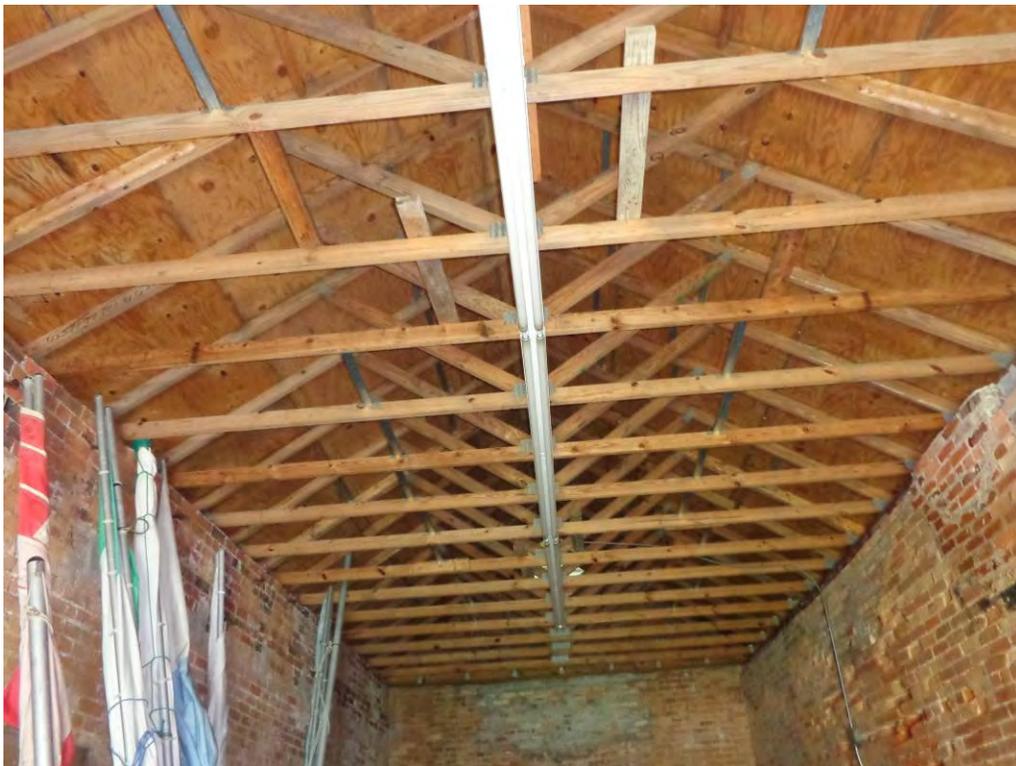
There is an attached storage building on the left side which is constructed with pre-engineered wood trusses (relatively new) and load-bearing masonry exterior walls. There is a small wood-framed connector that attaches the storage building to the main building.

Photograph 12 – Storage Building Roof Framing
