East Water Street Stormwater Evaluation

Town of Edenton, NC

September 2017

TWC 2478-FW

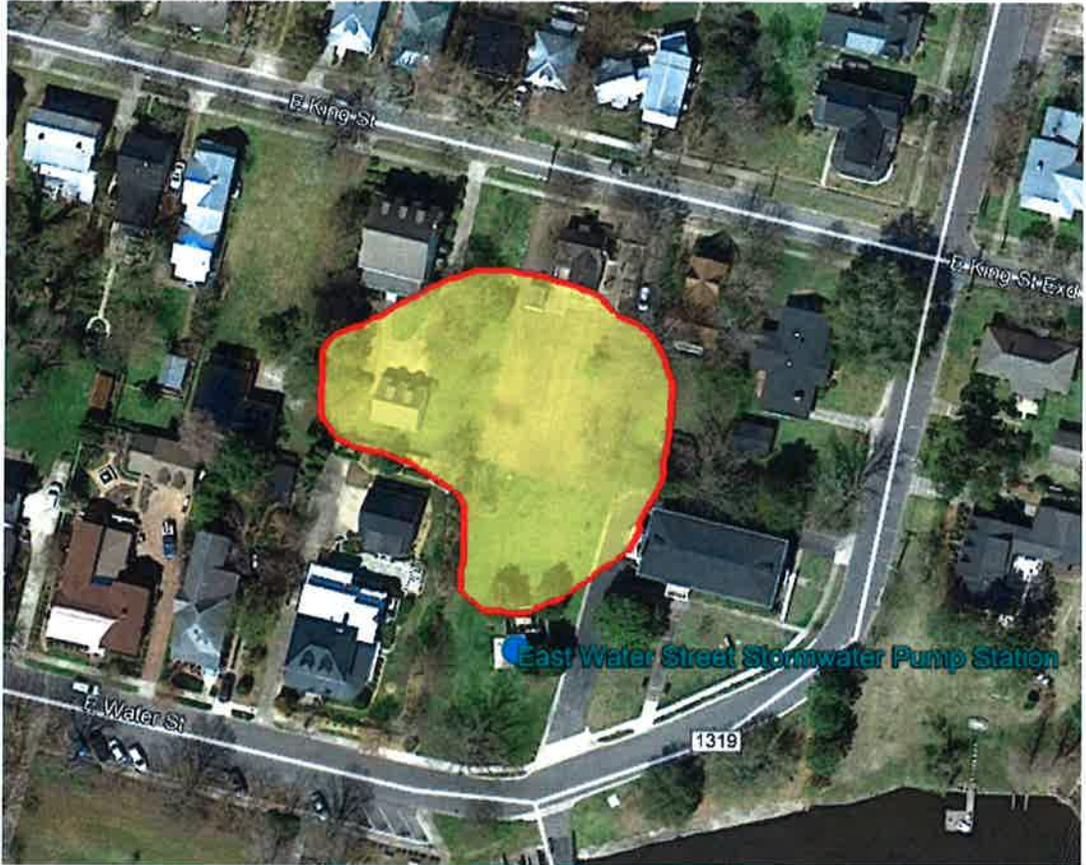
The terrain of this region creates a natural “bowl” located north of the East Water Street pump station. During significant rainfall events, stormwater water collected through the watershed is conveyed through street gutters, catch basins, gravity mains and swales. According to local accounts, as the station becomes overwhelmed, stormwater begins to backup within the system to the point of overtopping structures creating situations of sheet flow across properties along East King Street. Figure 2.1 indicates the area showing the greatest frequency of flooding events.

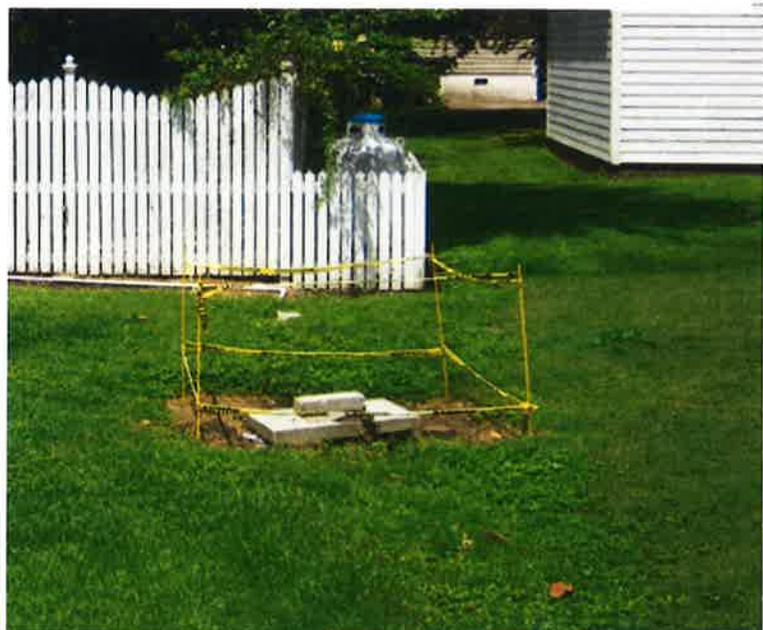
FIGURE 3.1

An integral component of the stormwater system is the conveyance of stormwater to the station. As mentioned above, the station currently has three (3) influent lines and when combined, these lines provide approximately 80,000 gpm capacity under full flow conditions. As such, the existing influent lines are sized to approximately carry the peak flow from the 50-year storm. To assist in the stormwater conveyance, it is recommended to replace an existing drop inlet located adjacent to the stormwater pump station. The inlet, situated over the 36-inch and 48-inch mains, provides a collection point for surface runoff currently conveyed by grassed swales in the adjacent properties to the pump station. Per citizen reports, currently this inlet is operating as the first overflow point for the system during heavy rainfalls. As improvements are implemented in and around the station, this drop inlet will become a pinch point in the system. The existing inlet appears to be a non-standard inlet with a concrete block placed on top of bricks (**Figure 3.1**). This presents an in-efficient flow pattern as well as creates a safety hazard for small children and wildlife.
